CPSC Staff Assessment on Eutectic-Type Thermal-Cutoff Fuse Failures in Shaded-Pole Motors Used in Exhaust Fans

December 2017

Arthur Lee
U.S. Consumer Product Safety Commission
Directorate for Engineering Sciences
Division of Electrical Engineering and Fire Sciences
5 Research Place
Rockville, MD 20850

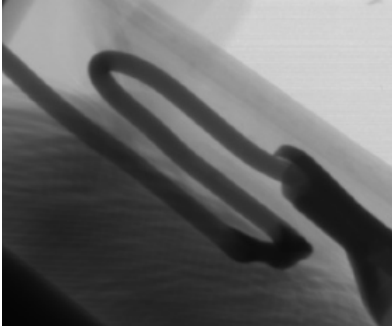
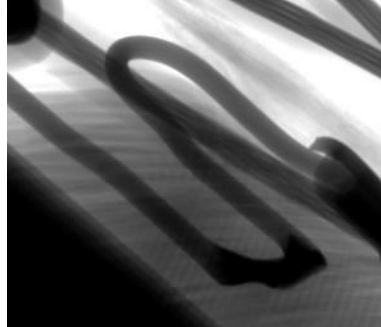
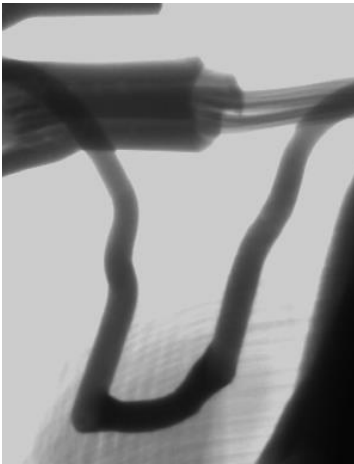
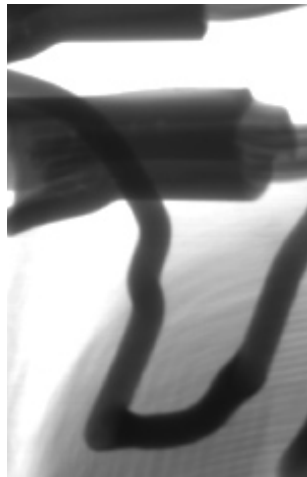
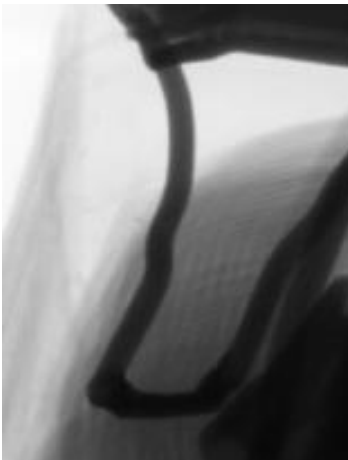
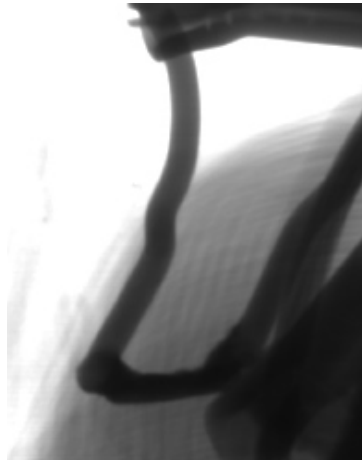
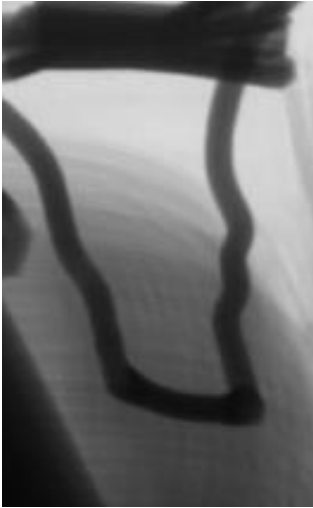
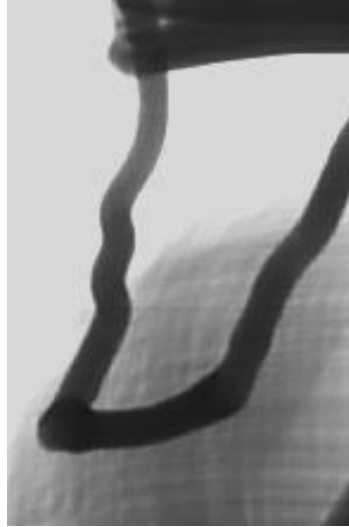
Figure 22 Thermal linkages before and after conditioning

For test group 3, all of the TCOs were x-rayed before and after conditioning. The thermal linkages did not appear visually to have changed after conditioning at 105°C for up to 305 hours. Figure 22 shows radiographs of the thermal linkages before and after conditioning for various lengths of time.

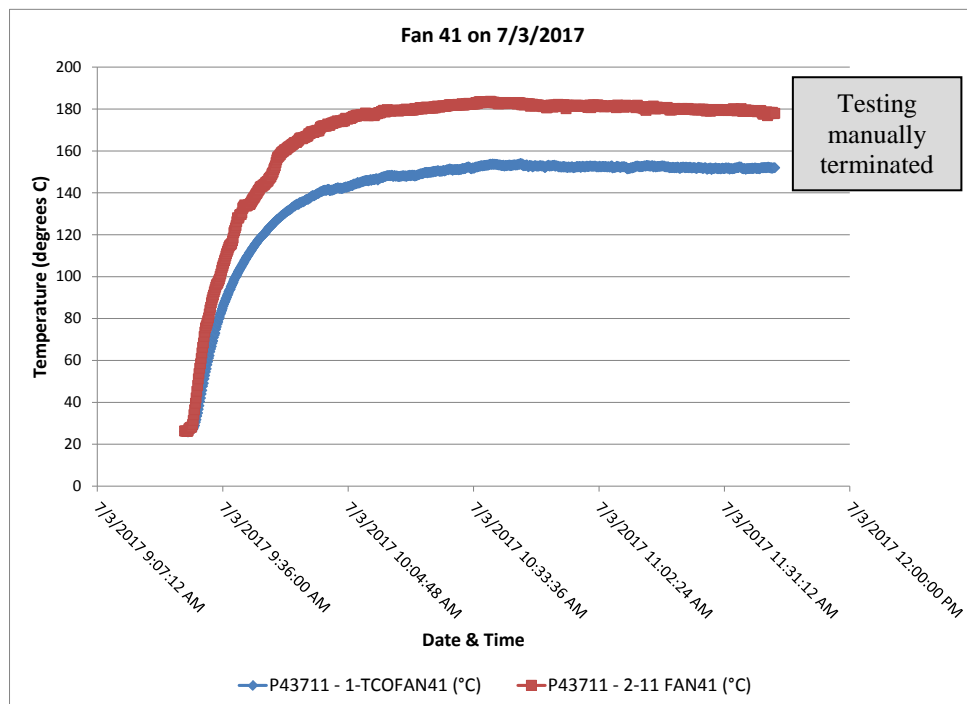
Figure 25. Temperature traces for Sub 41 Test Group 3 - Lock-rotor Test

Staff conditioned the fan (sub 41) for 232 hours 30 minutes. During the lock-rotor testing, the TCO did not activate. After about an hour, the temperature appeared to have leveled to a constant temperature or steady state. Staff terminated the lock-rotor testing after approximately 2 hours 30 minutes. Figure 25 shows the temperature traces for the thermocouples during the lock-rotor test on July 3, 2017.

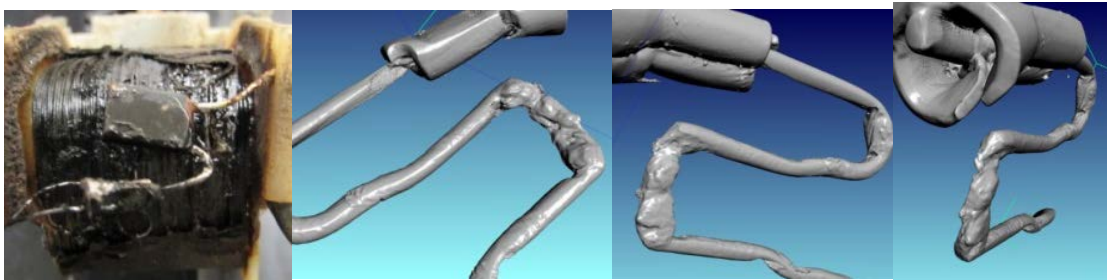
Figure 28. TCO from Sub 41 after Lock-Rotor Test

Post examination shows the TCO's fusible link to be intact, as shown by CT scans in Figure 28. During lock-rotor testing, the TCO failed to activate, but the event ended because the motor winding opened, thus de-energizing the motor.

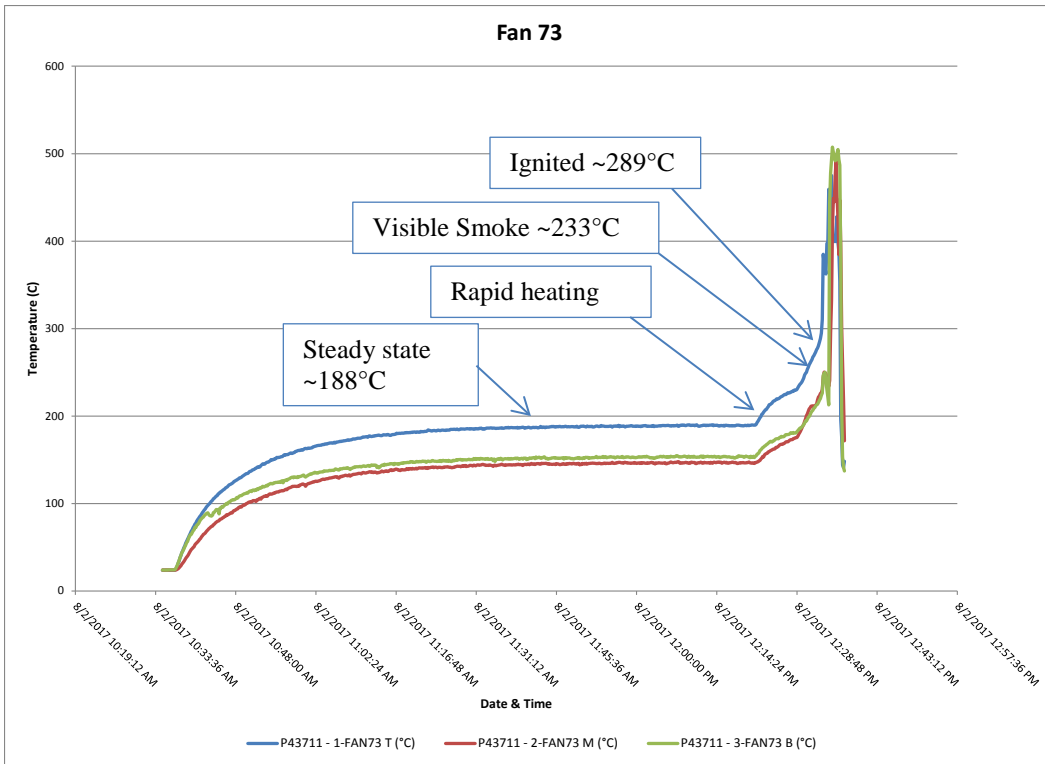
Figure 40. Winding temperatures during lock-rotor test for Fan sub 73

Fan sub 73 was in lock-rotor condition for about 1 hour and 56 minutes before the unit ignited, as shown in Figure 40. The fan’s winding temperature was at a steady-state temperature (~188°C) above the TCO function temperature for about 1 hour, until the winding temperature began to increase rapidly. This rapid increase in temperature is an indication of shorting in the winding, which reduces the winding resistance and increases the current. Before ignition, with the winding temperature at about 233°C, the unit was producing visible white smoke. When the unit ignited around 289°C, there was a large flash and flames for a brief moment. It appears that the gaseous vapors driven off the winding coating ignited. The flames subsided slightly until the wrap around the winding and the coating on the windings started to burn, growing in intensity. The flames impinged on and ignited the plastic impeller. The burning impeller and bobbin resulted in dripping flaming plastic. Four layers of cheesecloth were placed under the fan to be used as an ignition indicator to verify that the dripping plastic continued to burn as it landed on the surface below. The dripping flaming plastic caused the cheesecloth to ignite, which indicates that the fan’s plastic grill could also ignite in this type of situation. Figure 41 shows a sequence of photographs demonstrating the progression during lock-rotor testing on sub 73.

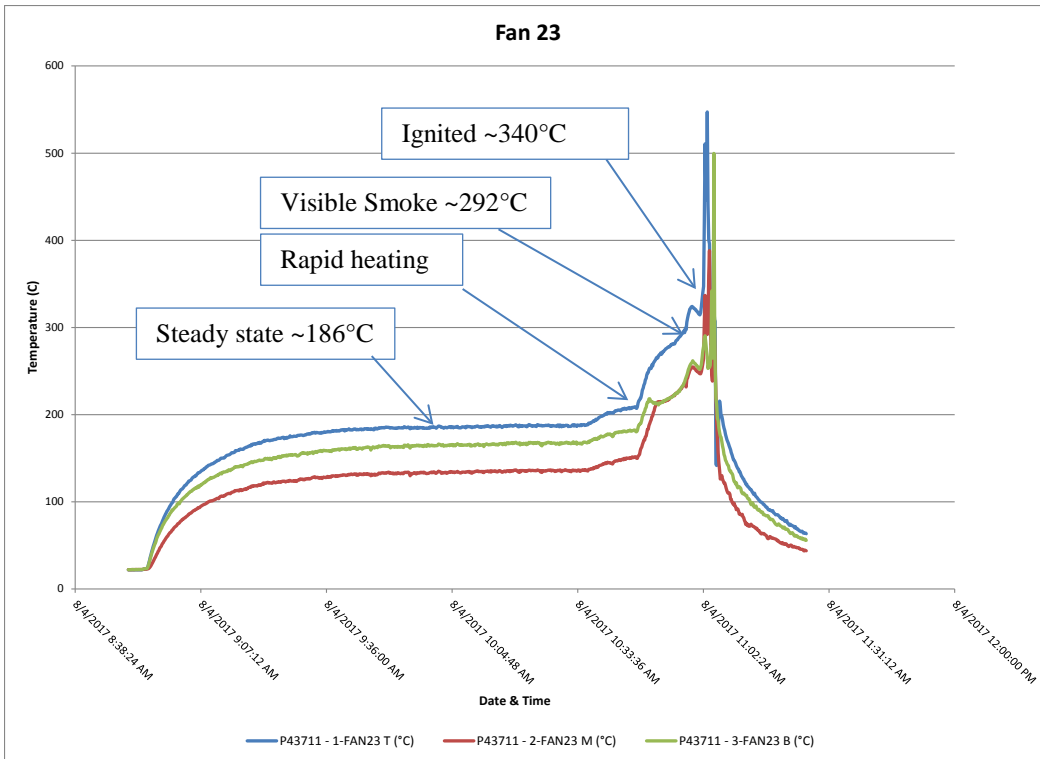
Figure 44. Winding temperatures during lock-rotor test for Fan sub 23

Fan sub 23 was in lock-rotor for about 2 hours and 40 minutes before the unit ignited, as shown in Figure 44. The fan's winding temperature, $\sim 186^{\circ}\text{C}$, was at steady state, above the TCO specified activation temperature, until the winding temperature began to increase rapidly. This rapid increase in temperature indicates shorting in the winding, which reduces the winding resistance. Before ignition, at about $\sim 292^{\circ}\text{C}$, the unit was producing visible white smoke. Similar to Fan sub 73, when the unit ignited at $\sim 340^{\circ}\text{C}$, it produced a large flash and flames for a brief moment. The large flames subsided slightly, until the flames ignited more of the wrap around the winding and/or the coating of the winding. The flames impinged on and ignited the plastic impeller. The burning impeller and bobbin resulted in dripping flaming plastic. Four layers of cheesecloth were placed under the fan to be used as an ignition indicator. The dripping flaming plastic ignited the cheesecloth, which indicates that the fan's plastic grill could also ignite in this type of situation. Figure 45 is a sequence of photographs during lock-rotor testing for sub 23.

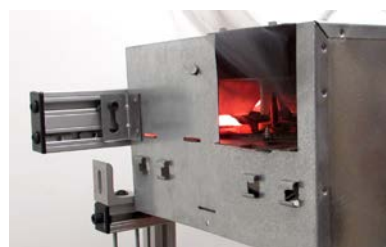
More of the winding wrap and the coating on the winding burns, thus creating a larger flame
