CPSC Staff Assessment on Eutectic-Type Thermal-Cutoff Fuse Failures in Shaded-Pole Motors Used in Exhaust Fans

December 2017

Arthur Lee
U.S. Consumer Product Safety Commission
Directorate for Engineering Sciences
Division of Electrical Engineering and Fire Sciences
5 Research Place
Rockville, MD 20850

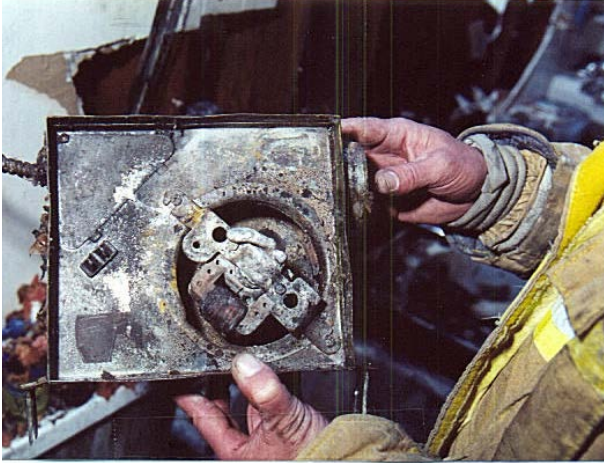
IDI 010402CCN474

In March 2001, at about 6:50 a.m. the fire department responded to an apartment structure fire. Firefighters discovered fire in the walls and the attic above the bathroom where the incident exhaust fan was located. Fire had spread into the common bathroom wall between apartment units and in the adjacent bedroom walls. The fire department determined that the fire started from a 30-year-old exhaust fan located in the bathroom of the apartment.

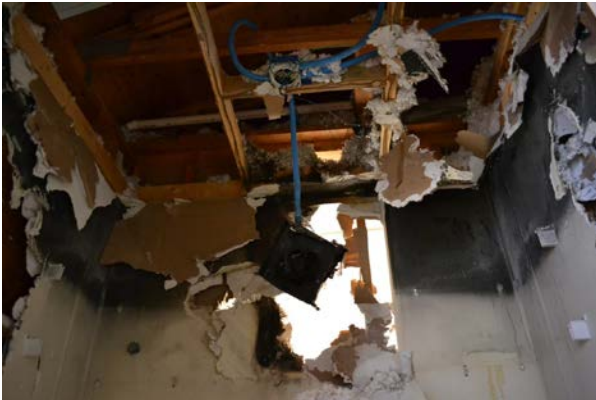
IDI 110322CCC2391

The incident occurred at a daycare facility. The building was built in 1995, and has been used as a daycare facility since its construction. The fans were original when the building was constructed. The lights and fans were controlled by a single switch. Five days a week, the switch was turned on at approximately 6:30 a.m. and turned off at about 7:00 p.m. The incident occurred in March 2011. After the daycare lights and fans were switched on, the daycare heat was also turned on. Approximately 1 hour later, a teacher and her assistant smelled something burning and assumed it was related to the heating system. Even though after the heating system was turned off, the burning smell persisted. The director went to the infant room and localized the burning smell to the changing room/bathroom. The director notified the owner of the daycare and was advised to disconnect the exhaust fans because they were old. The director was unplugging the exhaust fan when a “large fireball shot out” of the exhaust fan. The daycare was evacuated and the fire department was summoned to extinguish the fire.

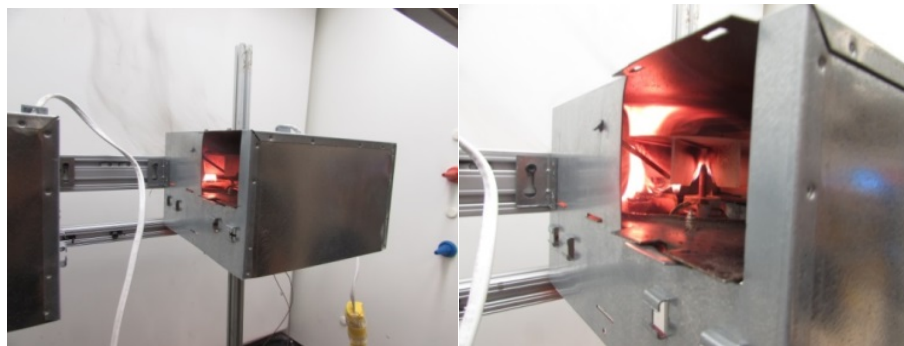
Figure 19. Bypassed TCO lock-rotor test

For the third test period, the fan was energized in the lock-rotor condition, and after about 30 minutes, the temperature increased rapidly, which resulted in smoke and flames. The thermocouple temperature traces are shown in Figure 18. The motor winding ignited, which then ignited the plastic impeller, as shown in Figure 19. The plastic impeller resulted in dripping, flaming plastic. The total lock-rotor test time was about 4.5 hours (period 1 + period 2 + period 3).

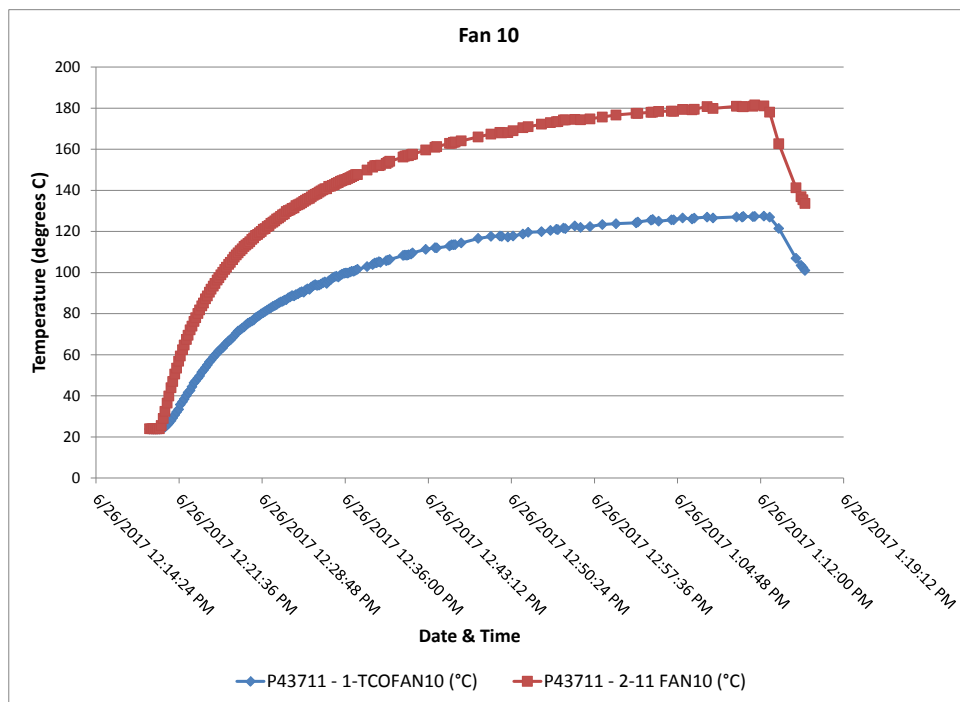
Figure 23. Temperature traces for Sub 10 Test Group 3 - Lock-Rotor Test

Staff conditioned the fan (sub 10) for 64 hours 30 minutes. During the locked-rotor testing, the TCO activated. The TCO activated approximately 52 minutes after the rotor was locked. The activation time was about 30 minutes longer than seen during typical lock-rotor testing, which activated around 20 minutes within the testing. Figure 23 shows the temperature traces for the thermocouples during the lock-rotor test.

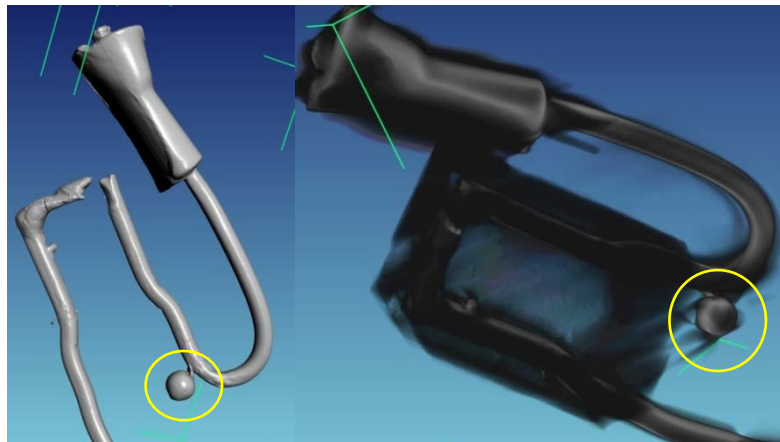
Figure 35. CT scans of the TCO showing the solder bead (Sub 99)

Post examination revealed the TCO had a solder bead external to the TCO casing. Figure 35 shows the CT scans with the partially melted fusible link after the testing, thus, indicating the TCO did activate, but abnormally. Microscopic images show that the solder originated from inside the TCO because of solder located within the cracks between the epoxy seal and the lead wires. Figure 36 shows the microscope images of the solder bead and solder in the cracks.

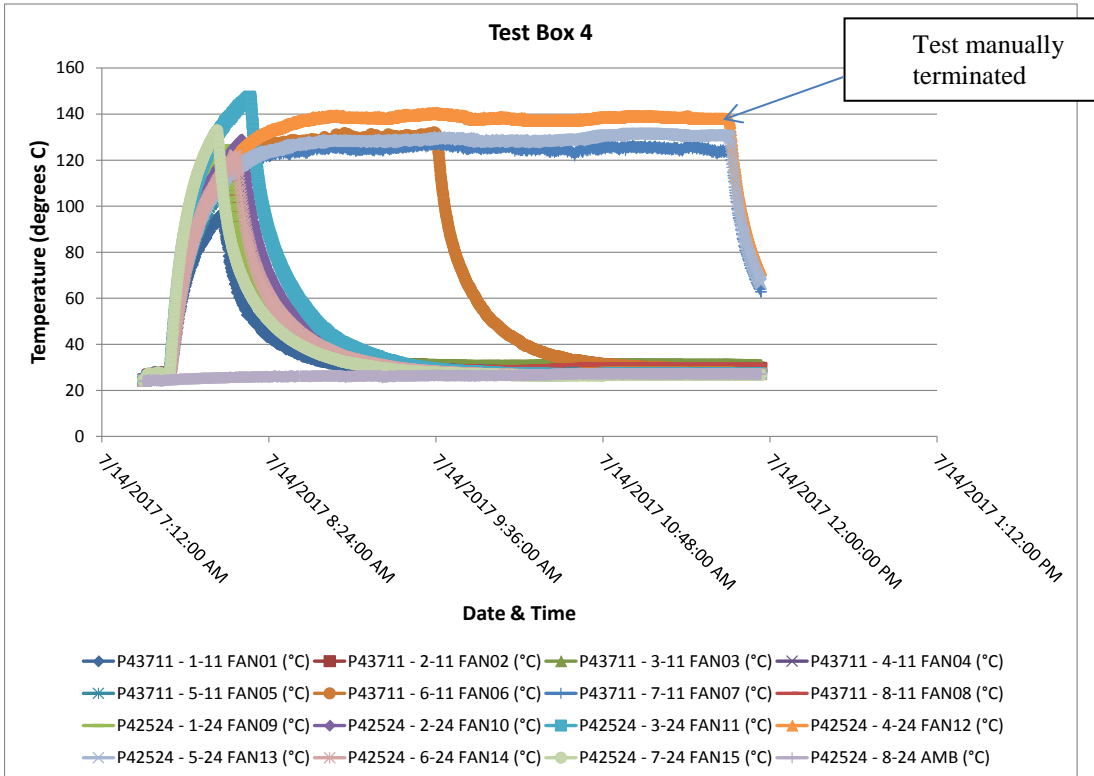
Figure 37. Temperature traces for Test Group 4 - Lock-Rotor Test

Test Group 4 had 15 fans. Staff placed the 15 fans in the conditioning oven at 2:30 p.m. on July 6, 2017. Staff set the conditioning oven at 105°C. After 165 hours (July 13, 2017 at 11:30 am), all 15 units were removed from the conditioning oven and installed in the large test frame. The fans were allowed to cool to room temperature before testing. A single thermocouple was placed on the side of the winding for each fan sample. The fans were tested in a lock-rotor condition on July 14, 2017. Figure 37 shows the temperature traces for Test Group 4 – Lock-Rotor Test.

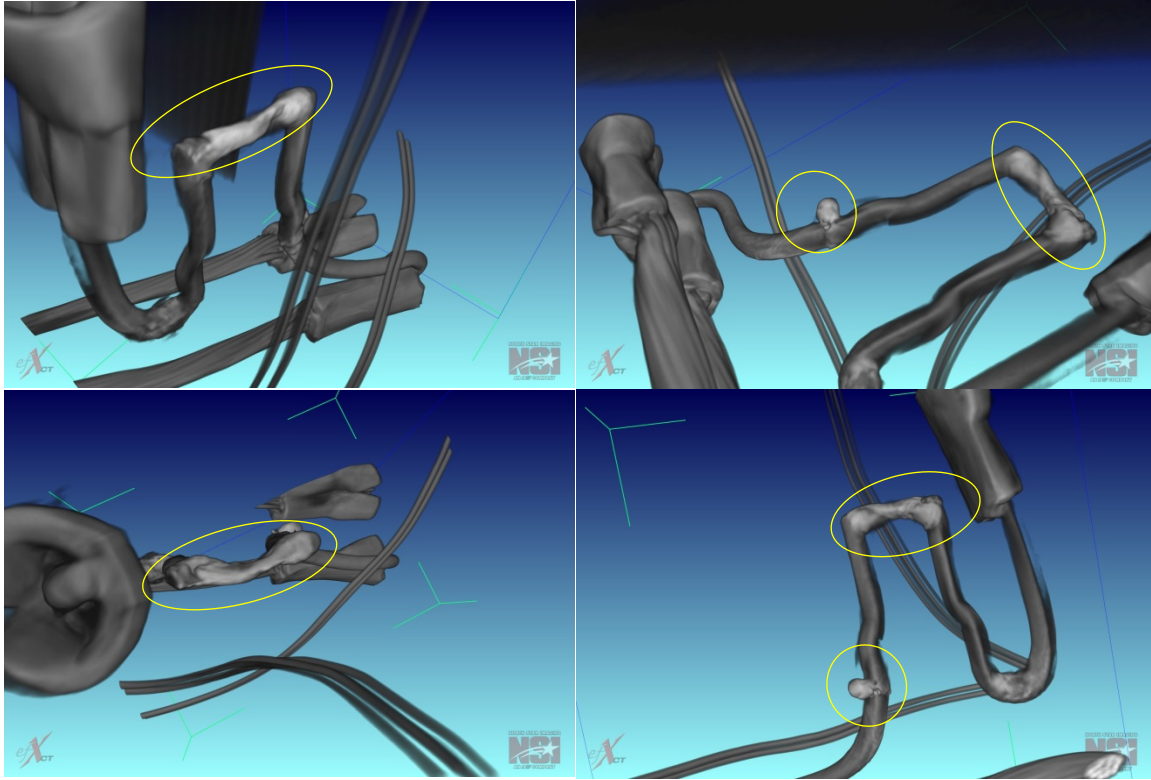
Figure 51. CT scans of the TCO after the test (sub 54)

Figure 51 shows CT scans of the TCO after the test. CT scans of the TCO confirm the solder link within the TCO is intact. The radiographs and CT scans show a solder bead has formed outside the TCO casing. This would suggest that the TCO is no longer hermetically sealed when thermally aged or placed under thermal stress. The reason that the windings were operating at such an elevated temperature for so long without eventually breaking down is not known, but it can be surmised that the winding coating would eventually deteriorate and cause shorts within the winding because the eutectic temperature has changed from T_f .

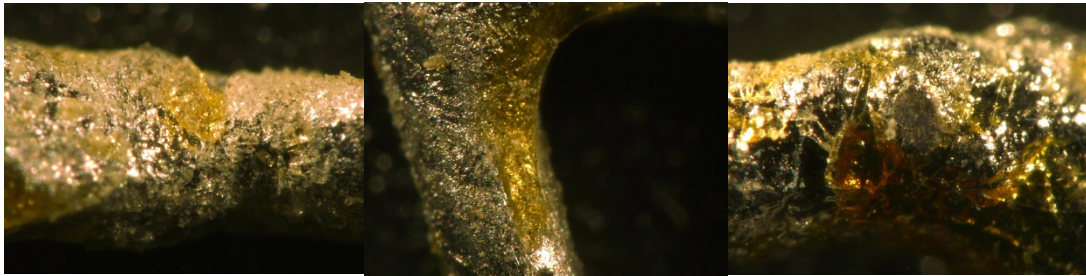
Figure 54. Close-up images of the TCO solder link (conditioned 330 hours @ 105°C)

Staff observed under a microscope that a yellowish substance was on the solder link, as shown in Figures 54 and 55. This was thought to be the special coating or flux material. Staff also observed that the conditioned TCOs appeared to have less of the yellowish substance than the TCOs that were unconditioned, but staff did not measure an actual mass content or volume of the substance for each sample.

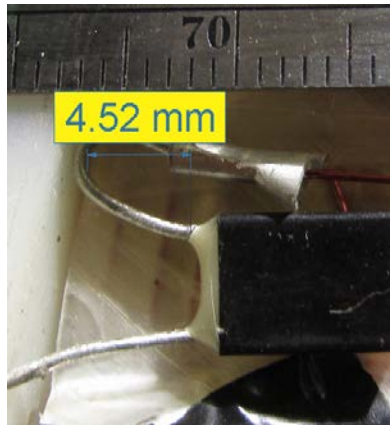
Figure 58. Wire bend lengths vary between TCOs in the Fan samples

Figure 58 shows the TCO wire lead bends can vary between fan motors. Even though sub 27 shows the wire lead bend greater than 3 mm, it appears that the base of the wire lead near the seal was not secured when the wire lead was bent, which is evident by the outward angle of the wire lead.

Wire lead with 0.19 mm length between the seal and bend (Sub 98)

Wire lead with 0.25 mm length between the seal and bend (Sub 26)

Wire lead with 4.52 mm length between the seal and bend (Sub 27)

Wire lead with 0.38 mm length between the seal and bend (Sub 79)

Improper bending of the wire lead may result in cracking of the epoxy seal, thus allowing solder to flow out and oxygen to enter the TCO and alter the functioning temperature of the TCO. Oxygen along with heat and time may also be a combination that could be accelerating the changes in the properties for the thermal linkage and the special compound.

- Lead wires (terminals) are to be bent or cut at least 3mm away from the TCO seals to avoid damaging the TCO (axial/radial type) or body (thin type). The TCO seals (axial/radial type) shall not be grasped with any tools or holders. Terminals of thin type TCO are to be grasped before they are bent. (See Fig. 1) (Reference - XICON PASSIVE COMPONENTS, Thermal Cutoffs (TCO)/Thermal-Links 447-XYP 1BF145-RC).
